FIREFLY BALLOONS 2010, Inc.

REPAIR AND MAINTENANCE MANUAL

INSTRUCTIONS FOR CONTINUED AIRWORTHINESS

The Balloon Works & FireFly Balloons TCDS A14SO
Galaxy Balloons TCDS A10NM

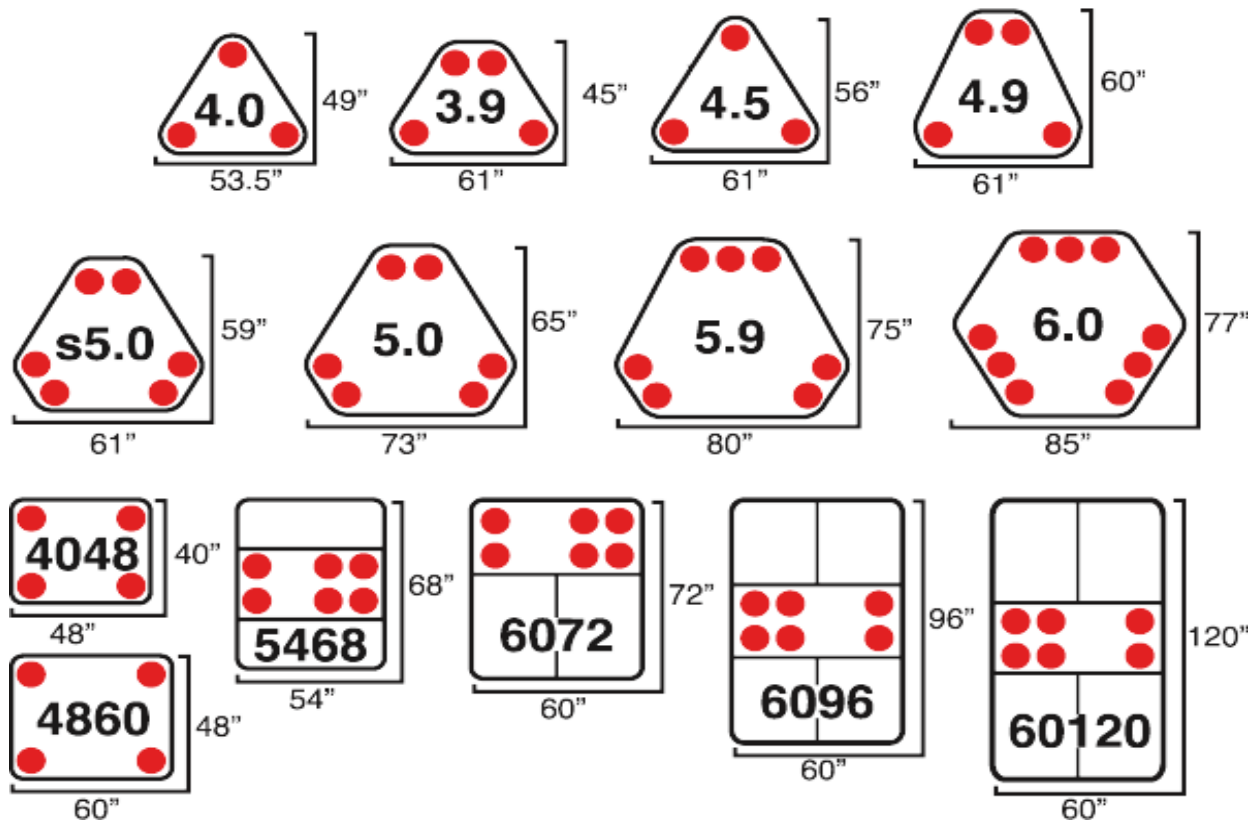
There are currently 8 triangle carriages in production. They are designated as 3.9, 4.0, 4.5, 4.9, 5.0, s5.0, 5.9, and 6.0. This designation generally indicates the distance in feet from the center of a side to the opposite corner. There are also 6 rectangular carriages in production. They are designated as 4048, 4860, 6072, 6096, 60120, and 5468. This designation indicates the nominal dimensions in inches of the carriage length and width. See Figure 2-2 for carriage data. Some carriage model numbers contain the suffix "A1." The carriage models 3.9, 4.0, 4.5, 4.9, s5.0, and 5.0 are identical to the carriage models 3.9A1, 4.0A1, 4.5A1, 4.9A1, s5.0A1, and 5.0A1 respectively, and may be used interchangeably.

Additionally, some carriage models will come with either one burner or two burners depending on customer preference. These carriages containing the optional second burner are denoted with a "DB" suffix after the model number. These carriages are 4.9DB, s5.0DB, 5.0DB, and 4860DB. Some triangle carriages were equipped with a throttle valve on one of the panels, these models have a "T" suffix on the model number. Some triangle carriages were made with adjustable uprights, these are known as the Barnestormer models and have a "B" suffix on the model number. The 6072 model carriage can be made with or without a partition, the partitioned carriage has a "T" suffix on the model number and is called the 6072T.

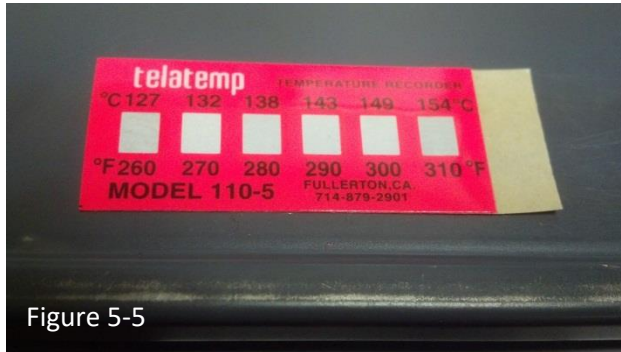
Figure 5-5

There are two types of Telatemp recording strips found in FireFly Balloons. Polyester fabric envelopes will have a recorder strip marked with the envelope serial number and are made for a temperature range of 270°F to 350°F (132.8°C to 176.7°C). Nylon fabric envelopes will have a recorder strip marked with the envelope serial number and are made for a temperature range of 260°F to 310°F (126.7°C to 154.4°C).

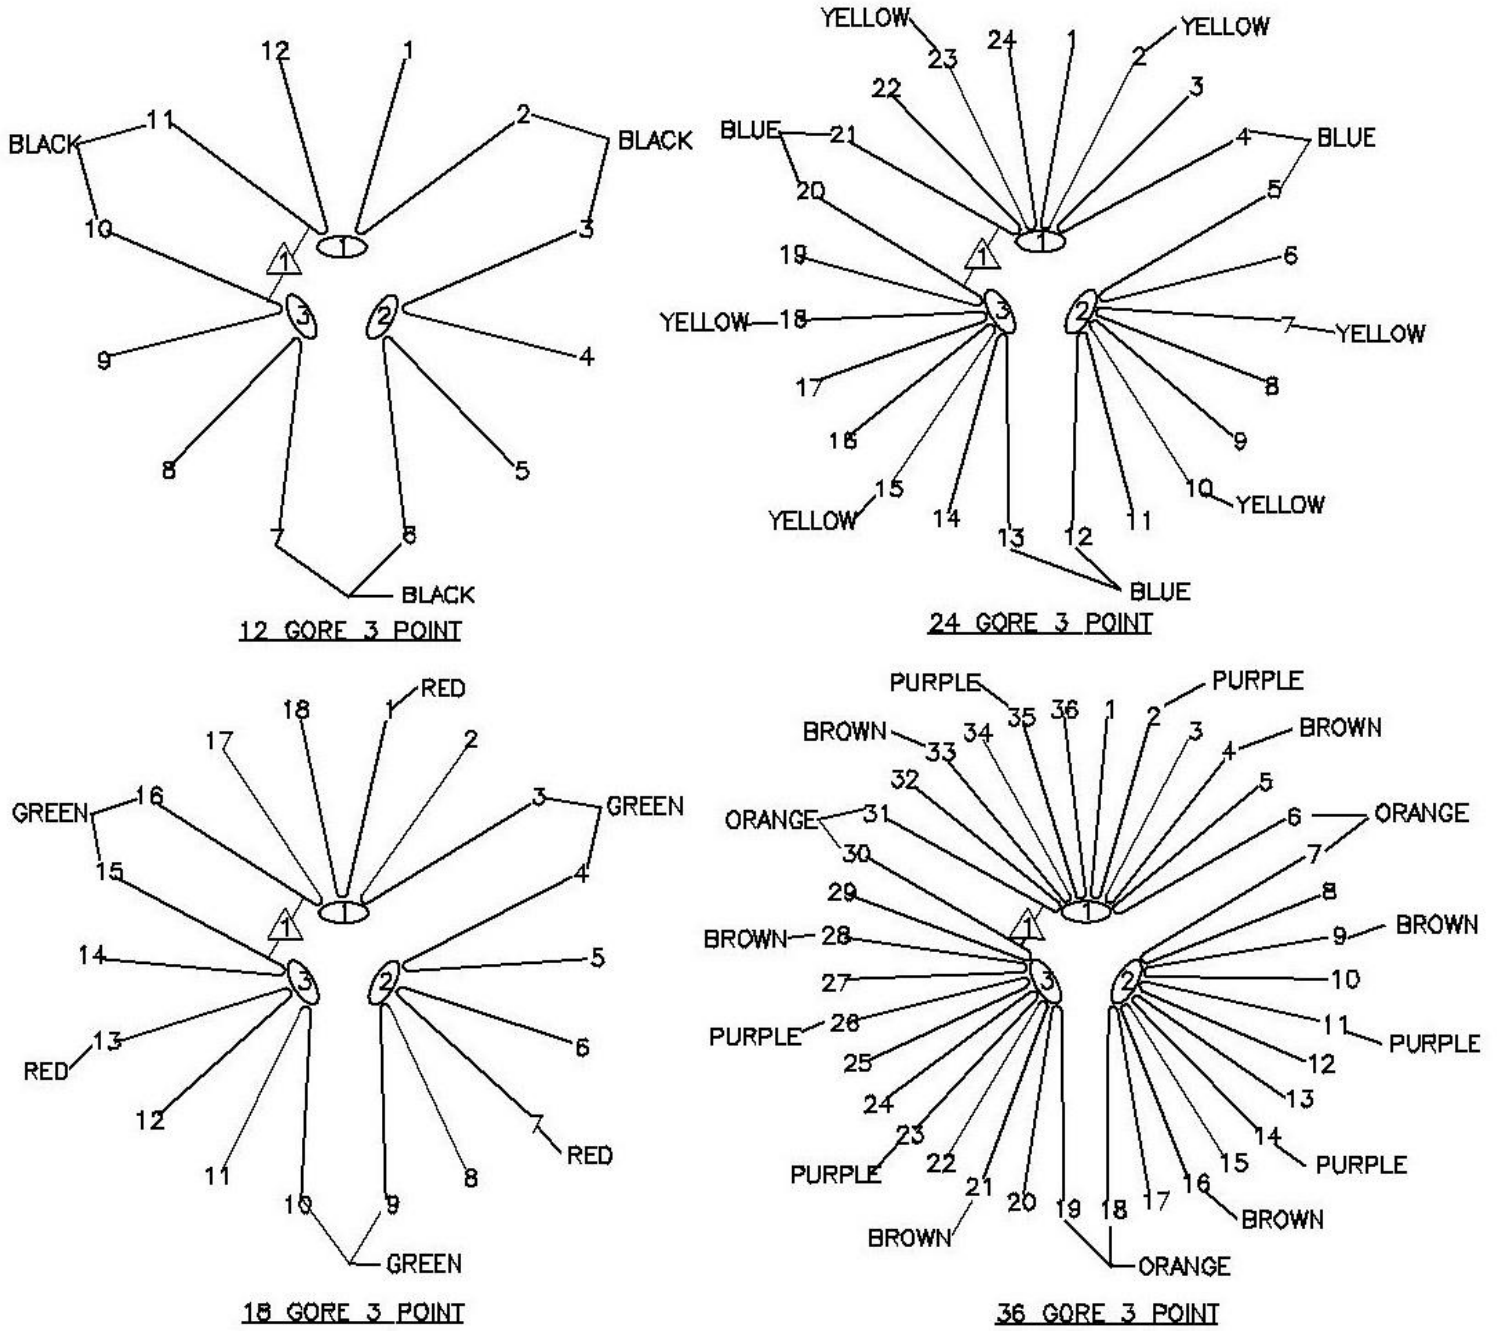
Figure 5-9 – THREE POINT SYSTEMS

NOTE: Represents location of temp sensor wires.

6. Reconnect the suspension cable to the load cord as shown in Figure 5-8. One leg of each cable pair is color coded. Be sure to replace the cables per the color coding shown in Figures 5-9 or 5-10. Reconnect temperature sensor leads if applicable, duplicating the required slack in the lead.

1. If individual cables are to be replaced, refer to Figures 5-9 or 5-10 to verify which pairs will be involved.
2. For each cable pair to be replaced, disengage cable at the load cord interface (see Figure 5-8) by cutting the retaining tie and disassembling. Disconnect envelope temperature sensor lead at the split bolt connector if applicable

1. A toggle assembly is one third (or one fourth) of a suspension cable set as shown in Figures 5-9 & 5-10.
2. Disengage cable eye spliced end at the load cord interface (see Figure 5-8) by cutting the retaining tie and disassembling. Disconnect the envelope temperature sensor lead at the split bolt connector if applicable
3. Reconnect the suspension cable to the load cord as shown in Figure 5-8. One leg of each cable pair is color coded. Be sure to replace the cables per the color coding shown in Figures 5-9 or 5-10. Reconnect temperature sensor leads if applicable, duplicating the required slack in the lead.
4. Install a new retaining tie on the load cord suspension cable interface.

The bottom girdle should be level at equilibrium and the carriage level. The girdle should appear to be in a straight line around the mouth of the balloon with no sharp peaks upward or downward. An abnormality in the girdle shape may indicate suspension cables are incorrectly installed. (See Figures 5-9 and 5-10 of this manual for proper cable color coding). It is possible, although unlikely, that the load cord could be secure stitched to the bottom girdle in an incorrect location.
